HISTORIC AMERICAN BUILDINGS SURVEY
INVENTORY

2. NAME *Orrin Thompson Mansion*

DATE OR PERIOD *1832*
STYLE *Greek Revival*
ARCHITECT
BUILDER *Orrin Thompson*

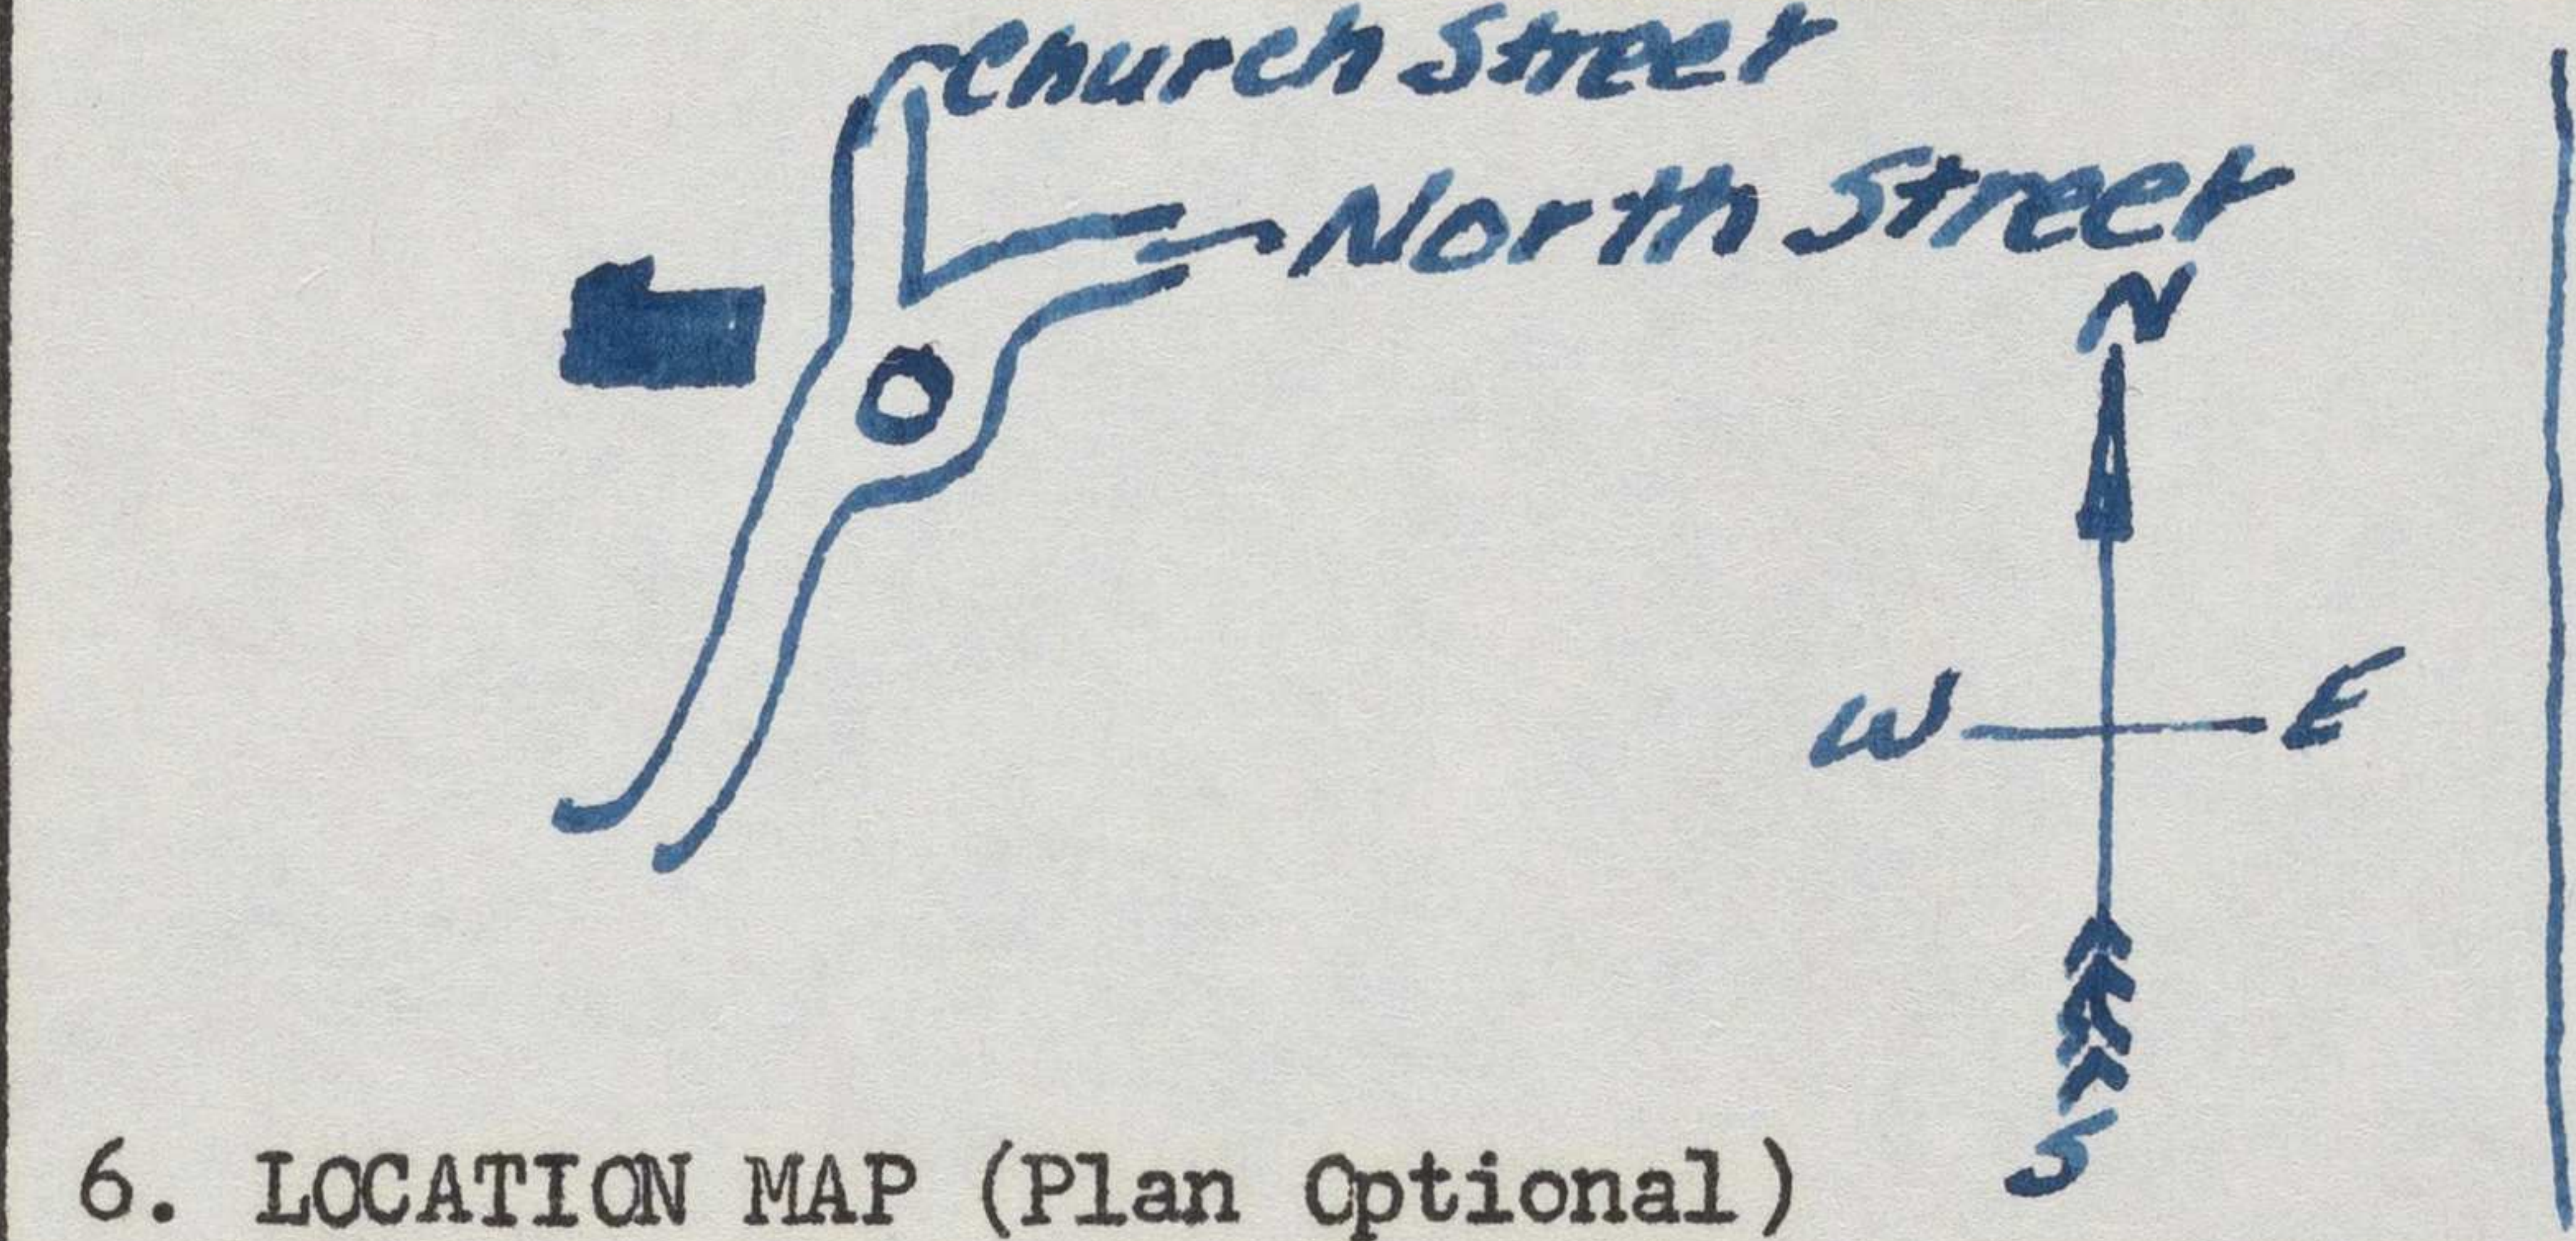
6. LOCATION MAP (Plan Optional)	7. PHOTOGRAPH <i>Enf 143</i>
---------------------------------	------------------------------

This building is accented by a spired tower to the N.E. The building is entirely brick with white brick and light stone dressings. Other than the tower, three bays face the street. Although there other window pane patterns elsewhere on the building the segmental topped windows are 6/6's. The center first floor bay has a non original door set in a portico decorated with 19th century dentil work. The roof of slight pitch and spire are slate covered.

5. PHYSICAL CONDITION OF STRUCTURE	Endangered <i>No</i> Interior <i>fair?</i> Exterior <i>fair</i>
------------------------------------	---

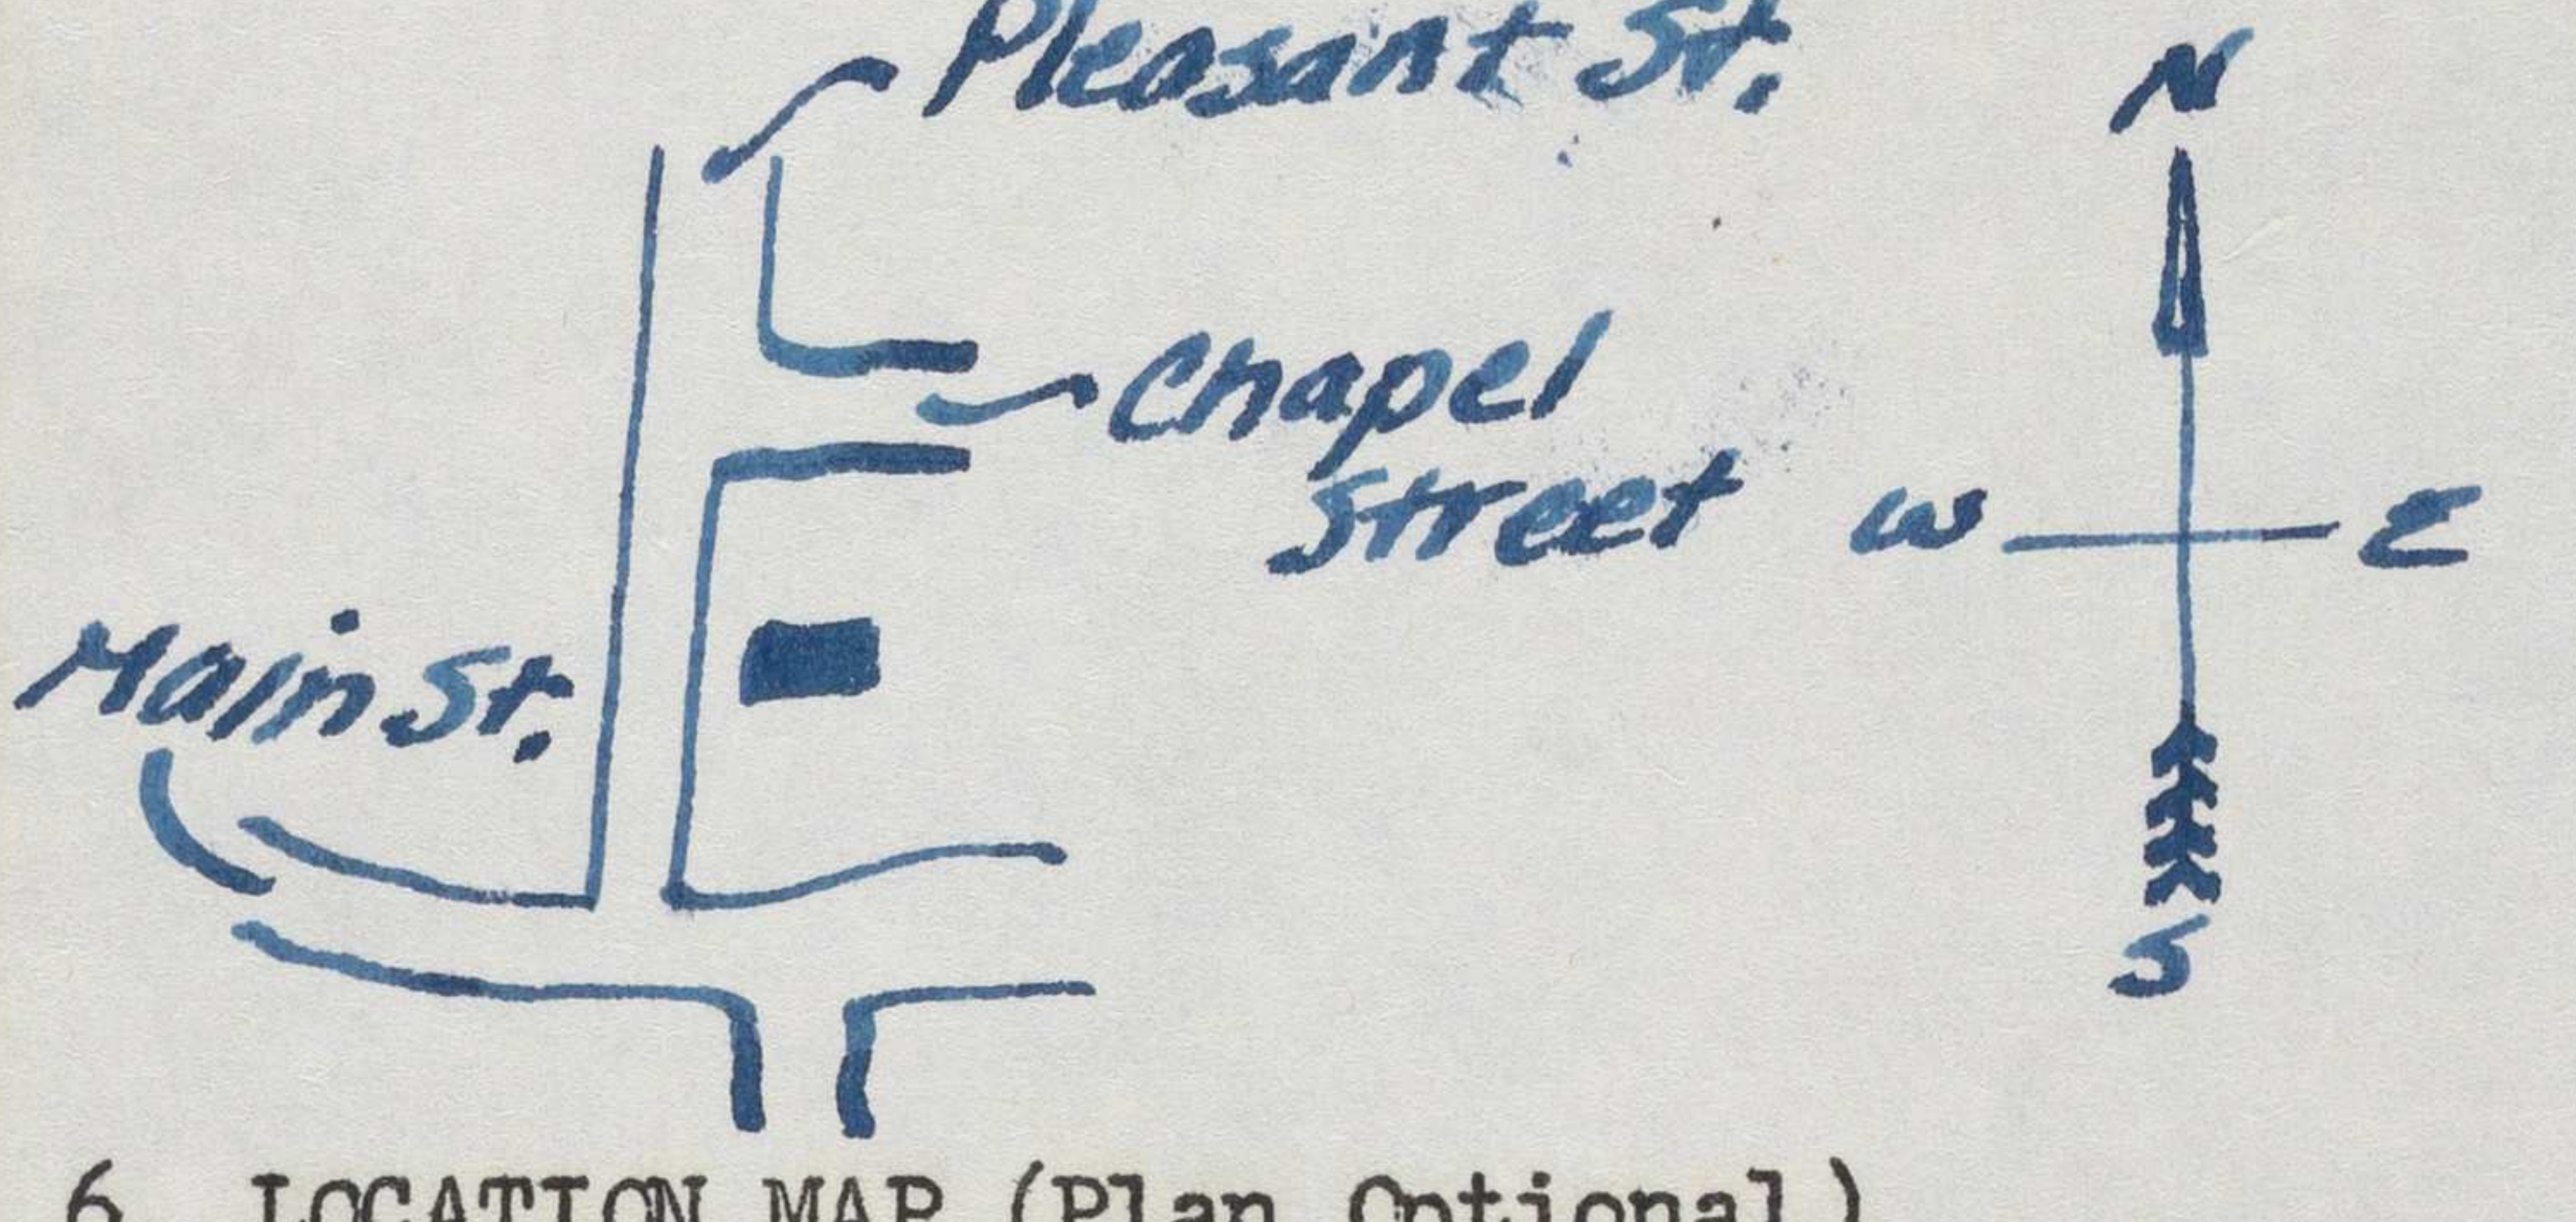
<p>7. PHOTOGRAPH <i>Enf 144</i></p>
<p>8. PUBLISHED SOURCES (Author, Title, Pages) INTERVIEWS, RECORDS, PHOTOS, ETC.</p>	<p>9. NAME, ADDRESS AND TITLE OF RECORDER</p> <p><i>Elric J. Endersby</i> <i>Director</i></p> <p>DATE OF RECORD <i>7/19/67</i></p>

<p>1. STATE <i>CT</i> COUNTY TOWN <i>Enfield</i> VICINITY STREET NO. <i>Pleasant Street</i></p> <p>ORIGINAL OWNER ? ORIGINAL USE <i>Residence</i> PRESENT OWNER ? PRESENT USE <i>Residence</i> WALL CONSTRUCTION <i>clapboard</i> NO. OF STORIES <i>2</i></p>	<p>HISTORIC AMERICAN BUILDINGS SURVEY INVENTORY</p> <p>2. NAME</p> <p>DATE OR PERIOD <i>1840?</i> STYLE <i>Greek Revival</i> ARCHITECT BUILDER</p> <p>3. FOR LIBRARY OF CONGRESS USE</p>
<p>4. NOTABLE FEATURES, HISTORICAL SIGNIFICANCE AND DESCRIPTION</p> <p>OPEN TO PUBLIC <i>No</i></p> <p><i>Pleasant Street is euphemism for a typical factory town thoroughfare, but this house retains a good deal of charm. Built upon the brick foundation of its period, the house has a shallow Revival roof accented with plain boarded pediment with a lowered segmental window. This is supported on a dentilled entablature and plain pilasters. The door is to the side and there are but two bays to the facade.</i></p>

<p>5. PHYSICAL CONDITION OF STRUCTURE Endangered ? Interior <i>Poor</i> Exterior <i>fair</i></p>	
<p>6. LOCATION MAP (Plan Optional)</p>

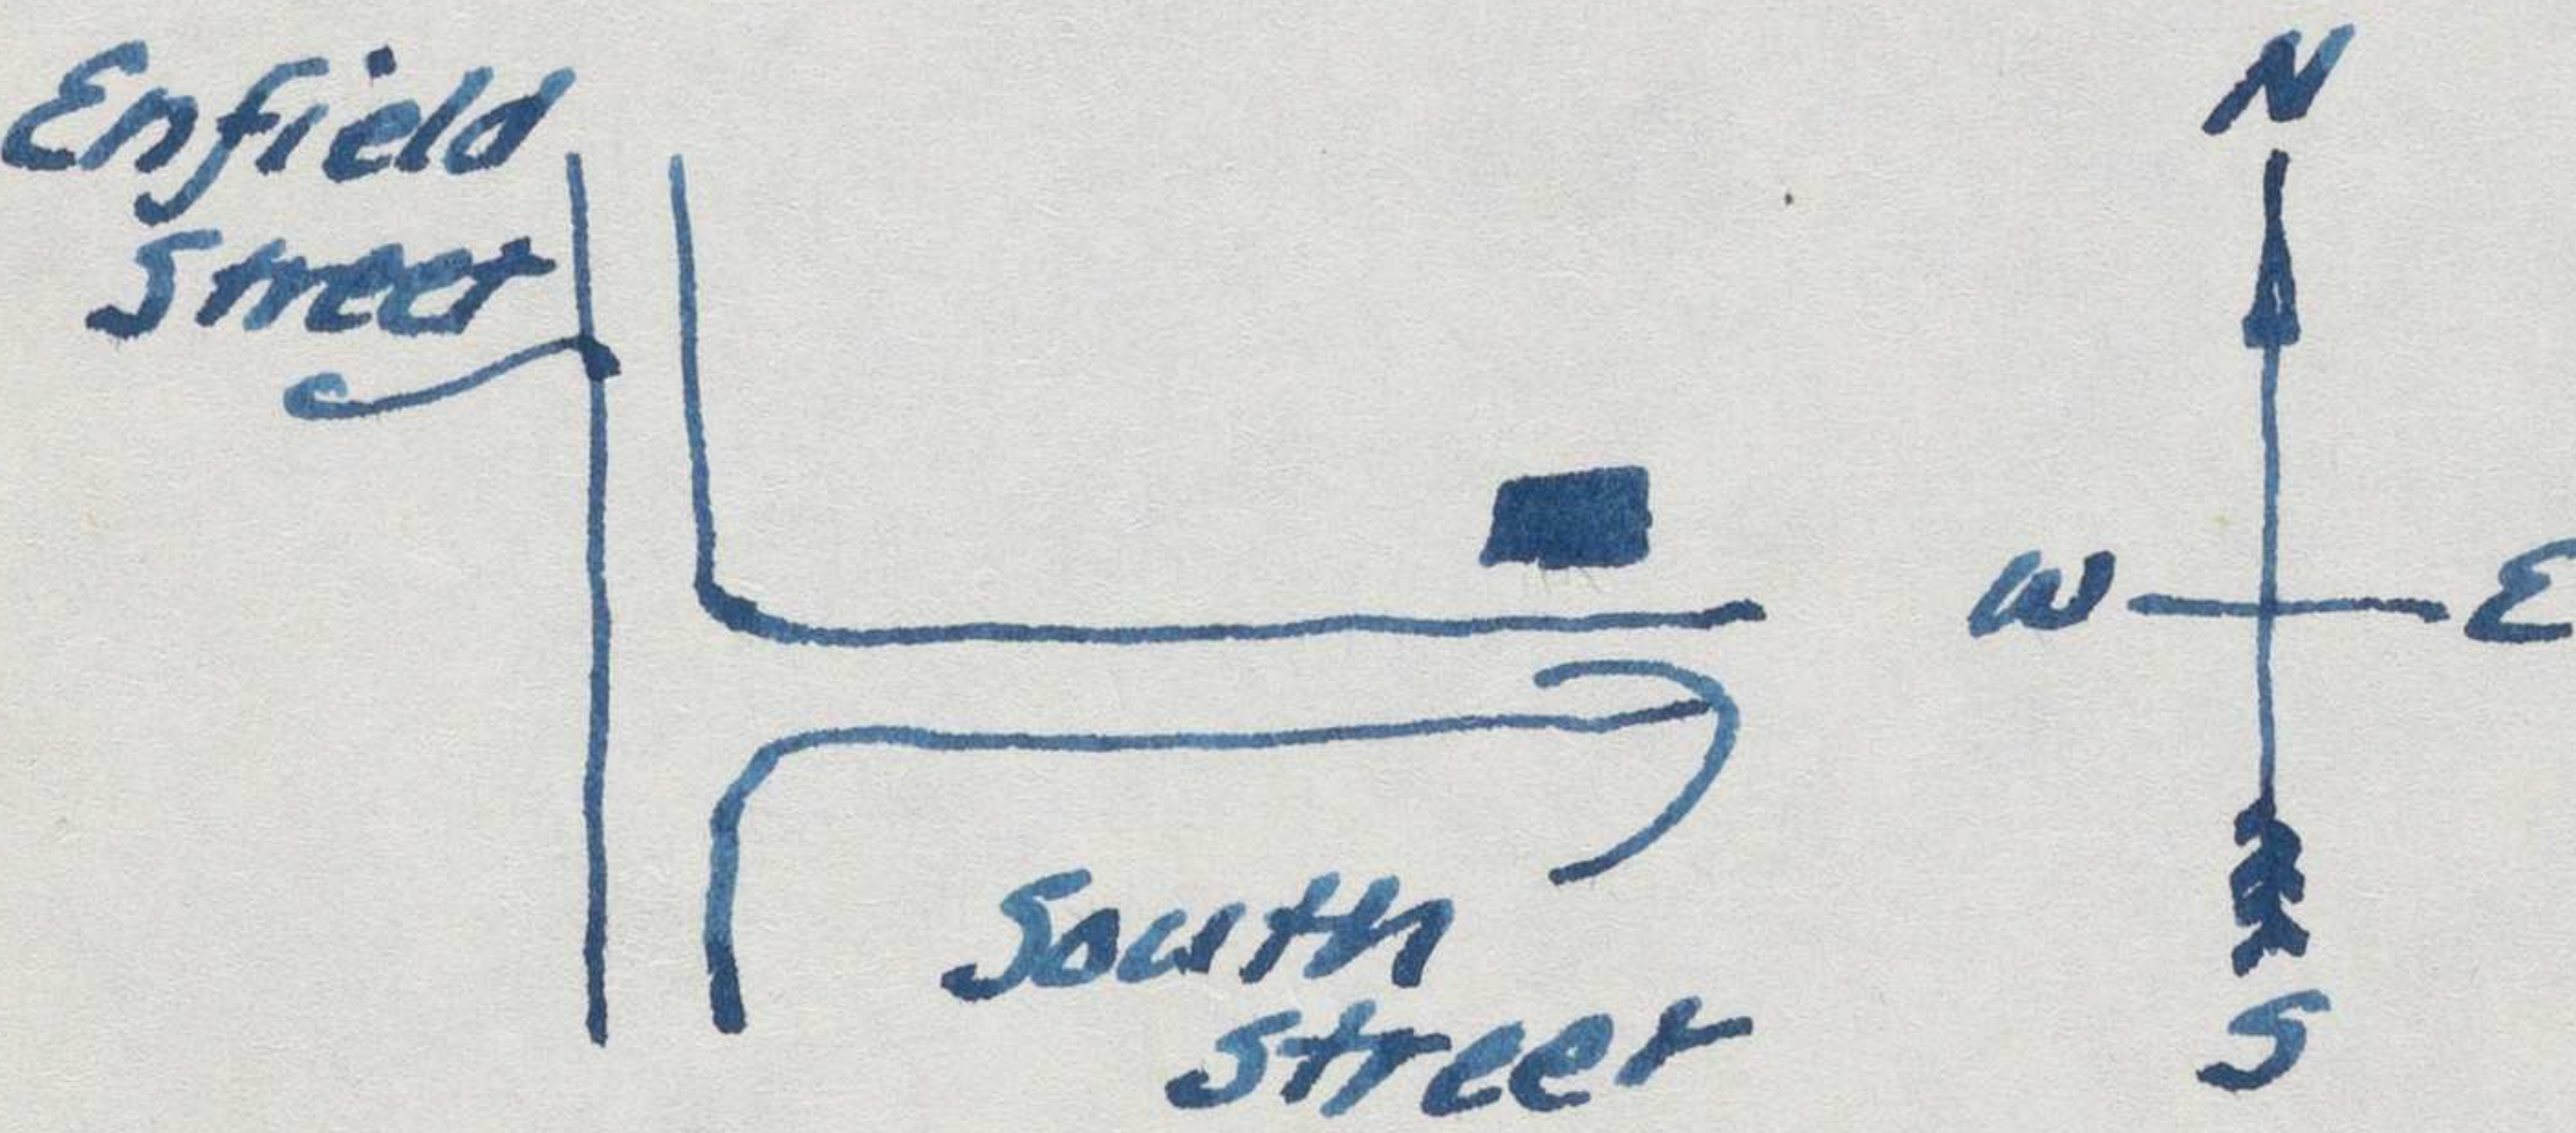
<p>7. PHOTOGRAPH <i>Enf 145</i></p>
<p>8. PUBLISHED SOURCES (Author, Title, Pages) INTERVIEWS, RECORDS, PHOTOS, ETC.</p>	<p>9. NAME, ADDRESS AND TITLE OF RECORDER</p> <p><i>Elmer J. Enderby</i> <i>Diag. Duobony</i></p> <p>DATE OF RECORD <i>7/19/67</i></p>

<p>1. STATE <i>CT</i> COUNTY TOWN <i>Enfield</i> VICINITY STREET NO. <i>1st house N side South St.</i> ORIGINAL OWNER? ORIGINAL USE <i>Residence</i> PRESENT OWNER <i>McDonald</i> PRESENT USE <i>Residence</i> WALL CONSTRUCTION <i>clapboard</i> NO. OF STORIES <i>1</i></p>	<p>HISTORIC AMERICAN BUILDINGS SURVEY INVENTORY</p> <p>2. NAME DATE OR PERIOD <i>1750?</i> STYLE <i>Georgian Colonial</i> ARCHITECT BUILDER</p> <p>3. FOR LIBRARY OF CONGRESS USE</p>
<p>4. NOTABLE FEATURES, HISTORICAL SIGNIFICANCE AND DESCRIPTION</p> <p style="text-align: right;">OPEN TO PUBLIC <i>No</i></p> <p><i>This house, were it in Massachusetts, would be called a "Cape Coddier." It appears to be quite old. Atop a brownstone foundation and under a 45° pitched roof it presents 3 bays (5 originally?) to South Street. The windows are 12/12 except for the attic story which has 9/9 panes. The new chimney is central, the door to the East side. There is an added dormer, and multiple additions to the side and rear.</i></p> <p>5. PHYSICAL CONDITION OF STRUCTURE Endangered <i>No</i> Interior <i>fair?</i> Exterior <i>fair</i></p>

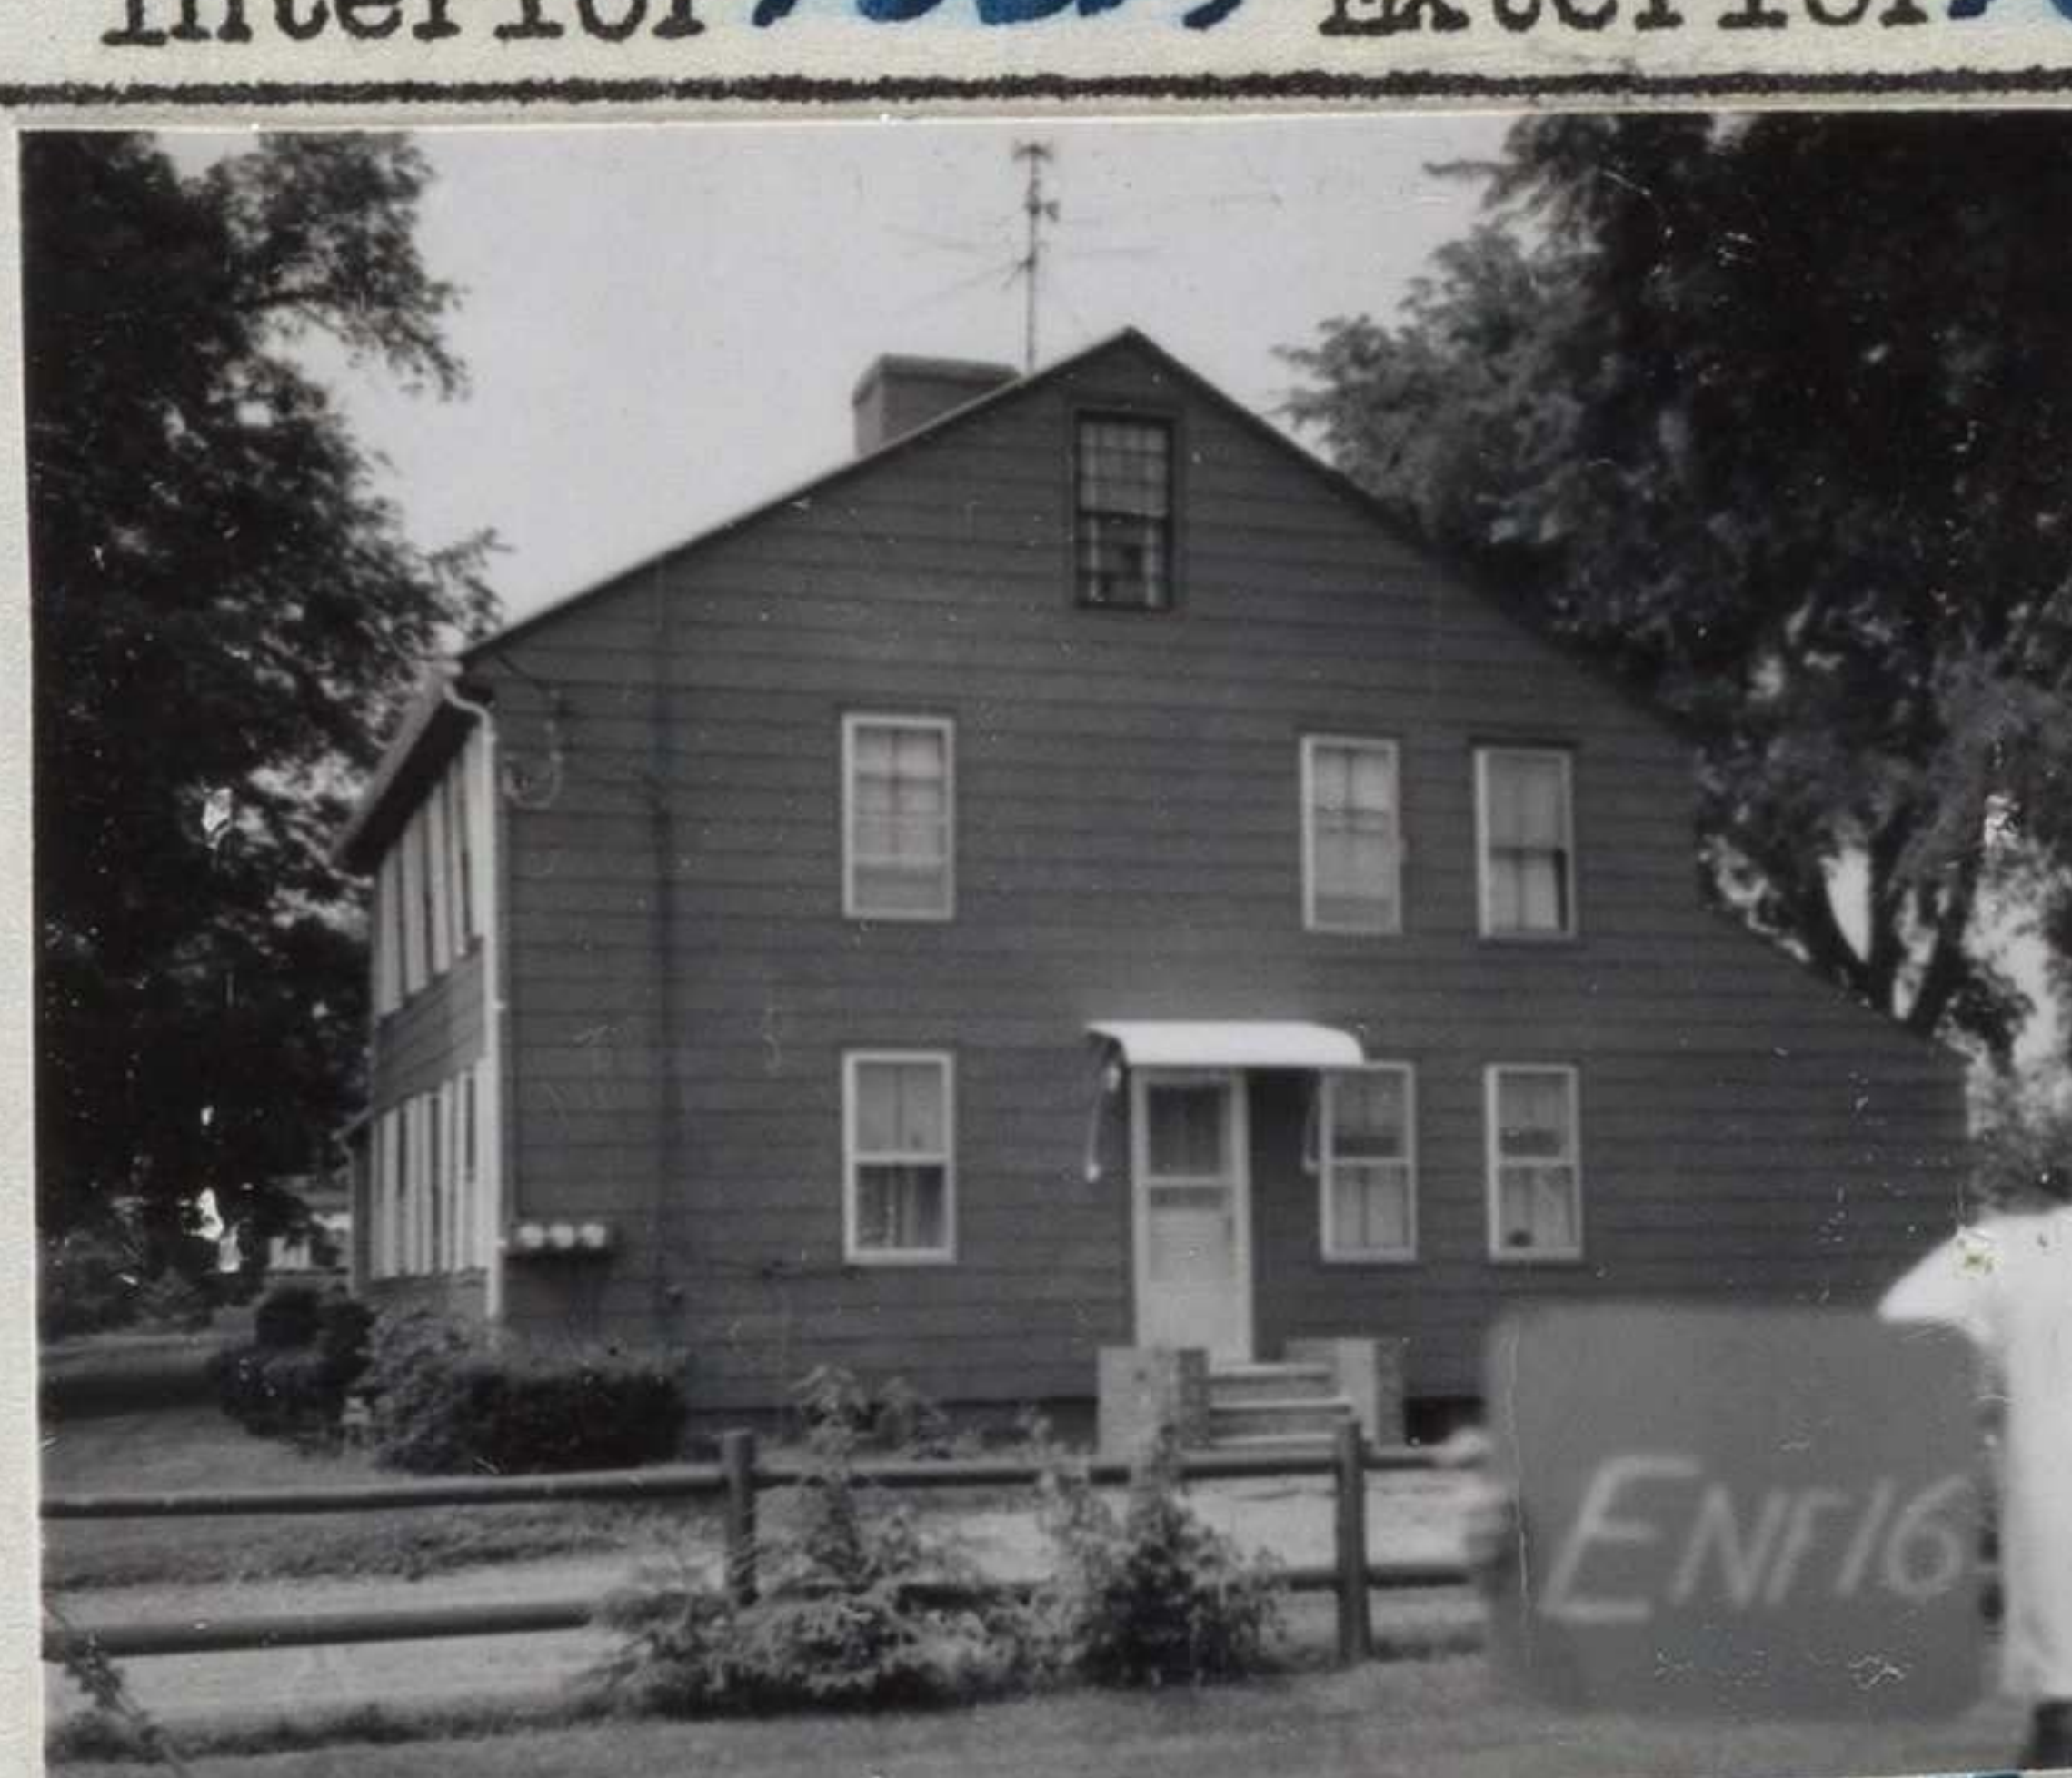
<p>7. PHOTOGRAPH <i>Enf 816</i></p>

<p>1. STATE <i>CT</i> COUNTY <i>Hartford</i> TOWN <i>Enfield</i> VICINITY STREET NO. <i>King + Enfield St.</i></p> <p>ORIGINAL OWNER ? ORIGINAL USE <i>Residence</i> PRESENT OWNER <i>Lindsey M. Carlson</i> PRESENT USE <i>Residence</i> WALL CONSTRUCTION <i>Joins-Mansville</i> NO. OF STORIES <i>2</i></p>		<p>HISTORIC AMERICAN BUILDINGS SURVEY INVENTORY</p> <p>2. NAME</p> <p>DATE OR PERIOD <i>1780?</i> STYLE <i>Georgian Colonial</i> ARCHITECT BUILDER</p> <p>3. FOR LIBRARY OF CONGRESS USE</p>	
<p>4. NOTABLE FEATURES, HISTORICAL SIGNIFICANCE AND DESCRIPTION</p> <p><i>This house may well have been a Bement house since the land was deeded to to the Bements in 1698. There is very, very little left of the original fabric. The foundation is of cut brown stone, the pitch of the roof, medium. The only original 12/12 windows are in the attic where so often "improvements" were not carried out by succeeding generations. There are but four bays bays to the original facade on Old King Street, the door having almost certainly been to the Enfield Street side. The large original chimney is central.</i></p>		<p>OPEN TO PUBLIC <i>No</i></p>

<p>5. PHYSICAL CONDITION OF STRUCTURE</p> <p>Endangered <i>No</i> Interior <i>Poor?</i> Exterior <i>Poor</i></p>			
<p>6. LOCATION MAP (Plan Optional)</p>

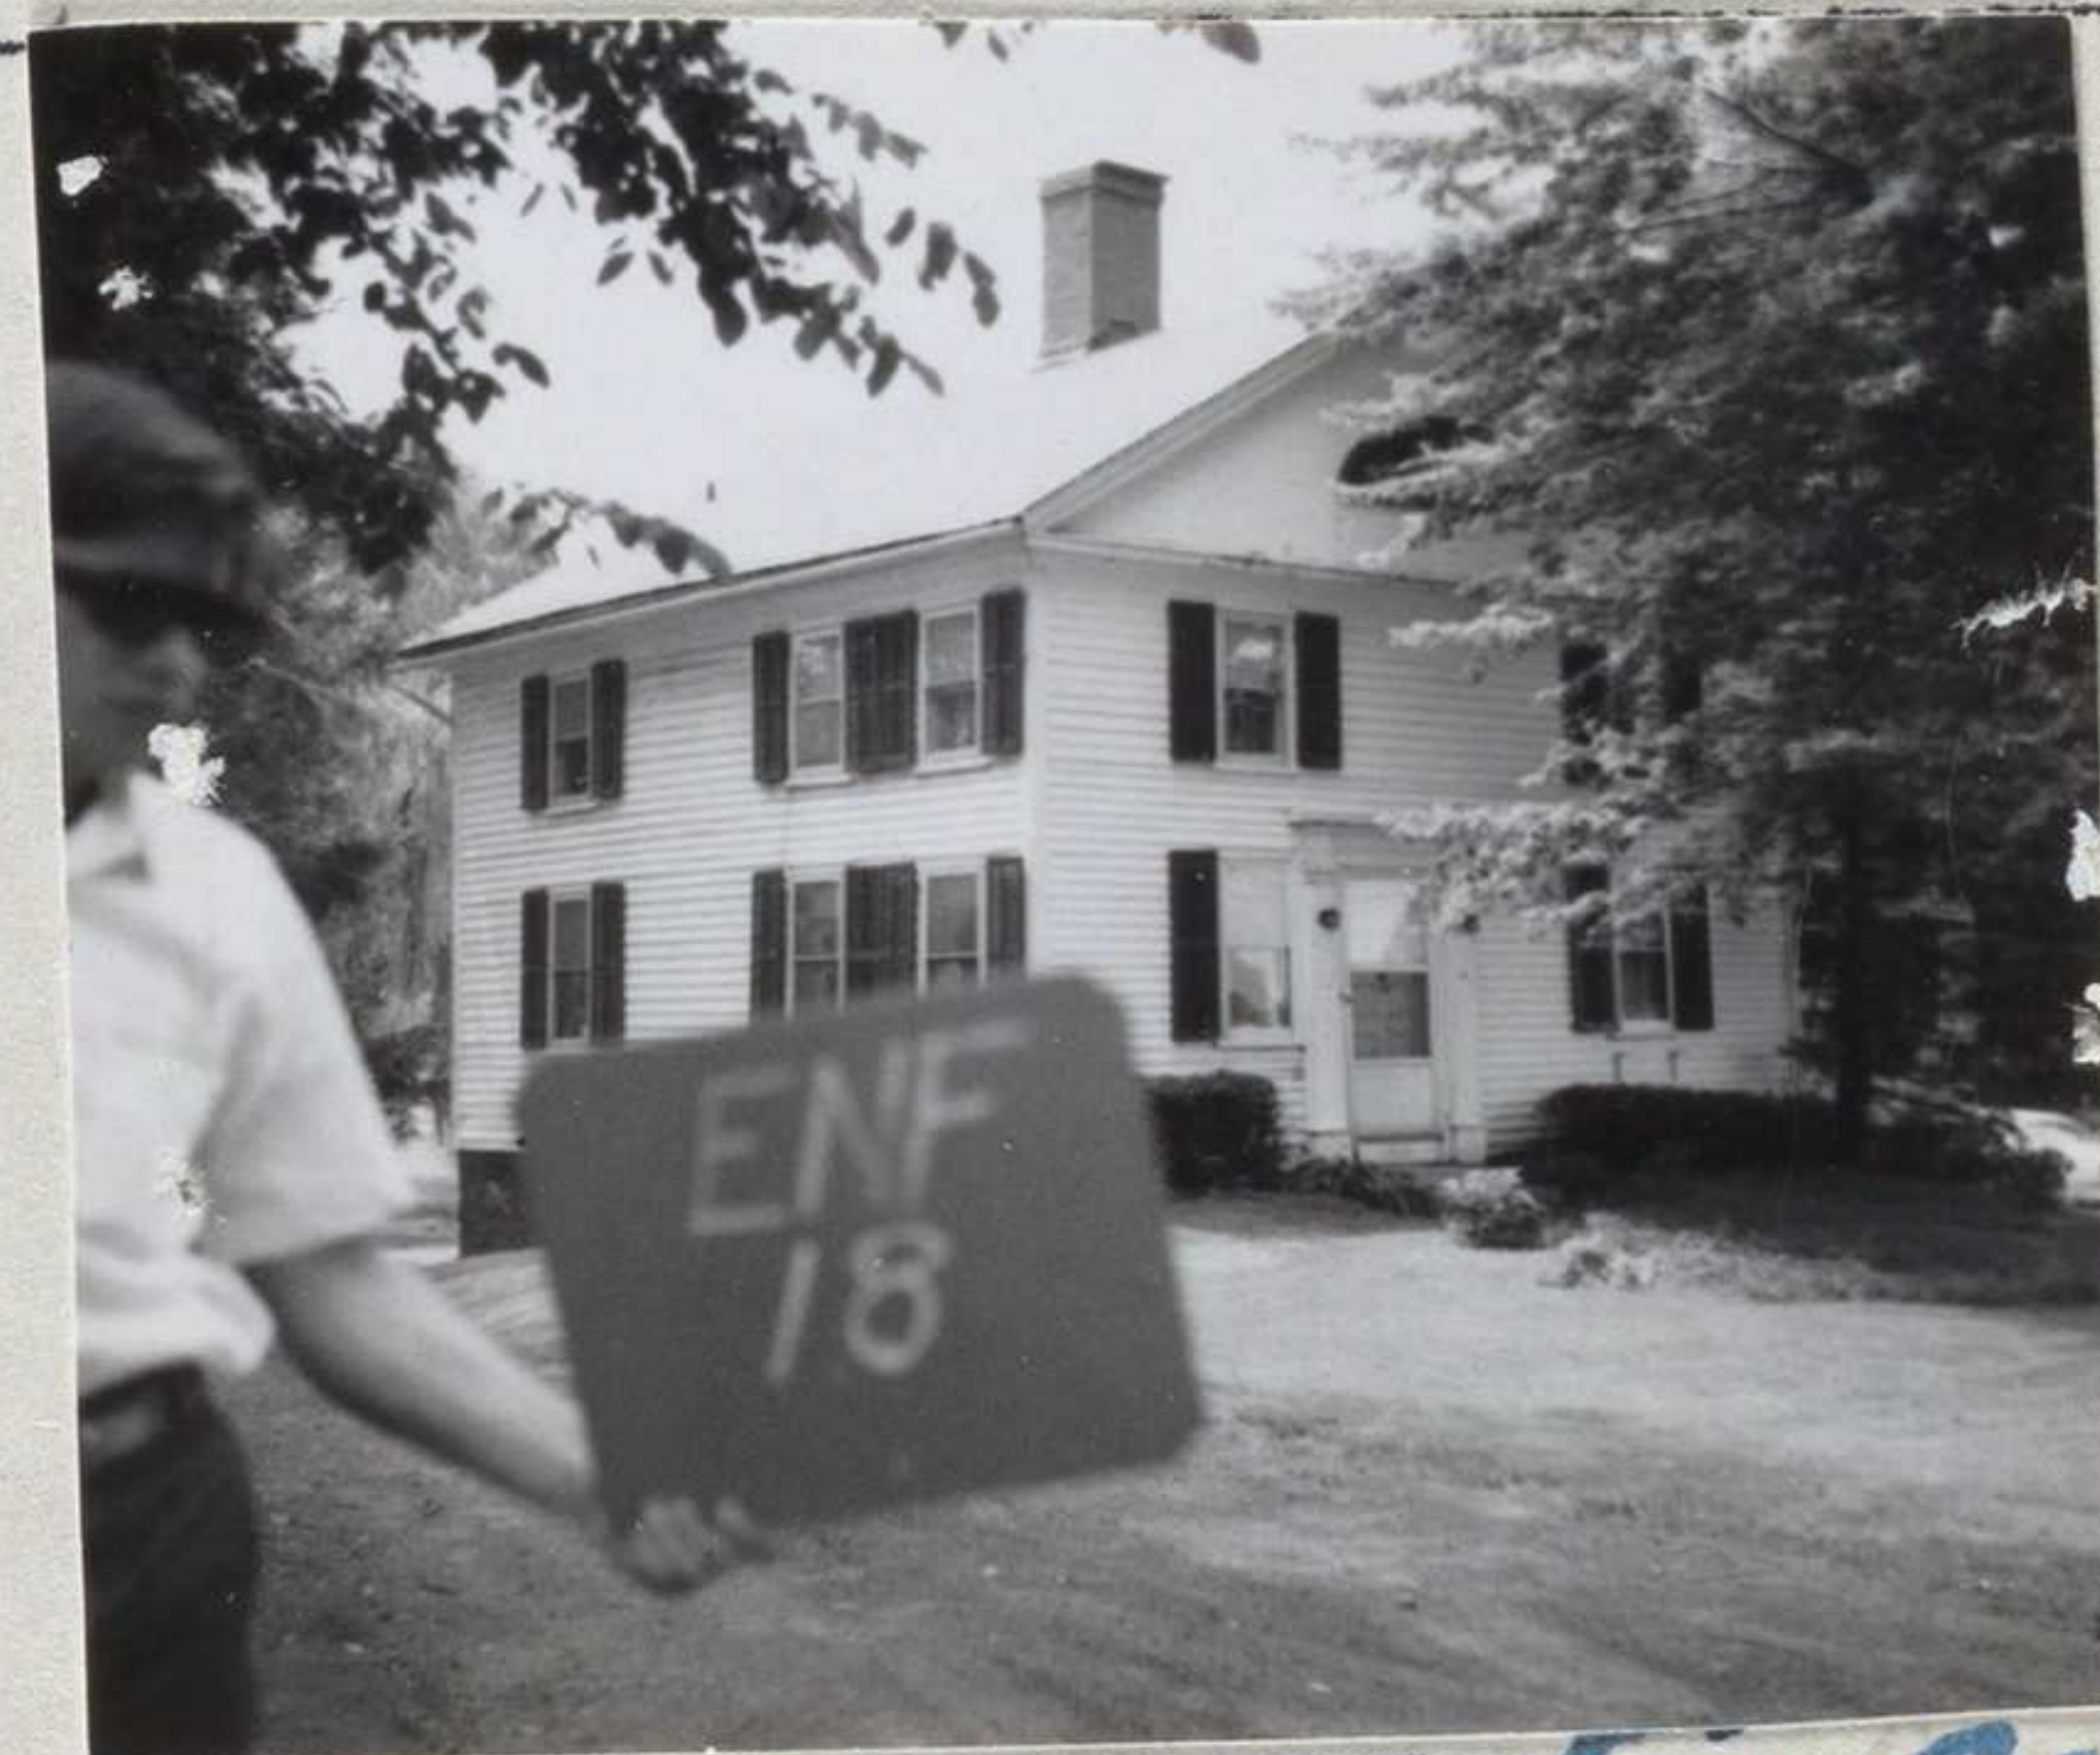
7. PHOTOGRAPH *Enf18*

*This house like most of the
 farmhouses in the area has had
 rather unsympathetic care. The
 main doorway has almost cer-
 tainly been moved but is original,*

*being framed in plain tapered doric pilasters. The
 main floors are faced in clapboarding but the
 shallow pediment of accentuated molding is
 flat boarded in somewhat wider widths. A typi-
 cal segmental window is centered in this space.
 The foundation is cut brownstone.*

5. PHYSICAL CONDITION OF STRUCTURE Endangered Interior *poor?* Exterior *fair*

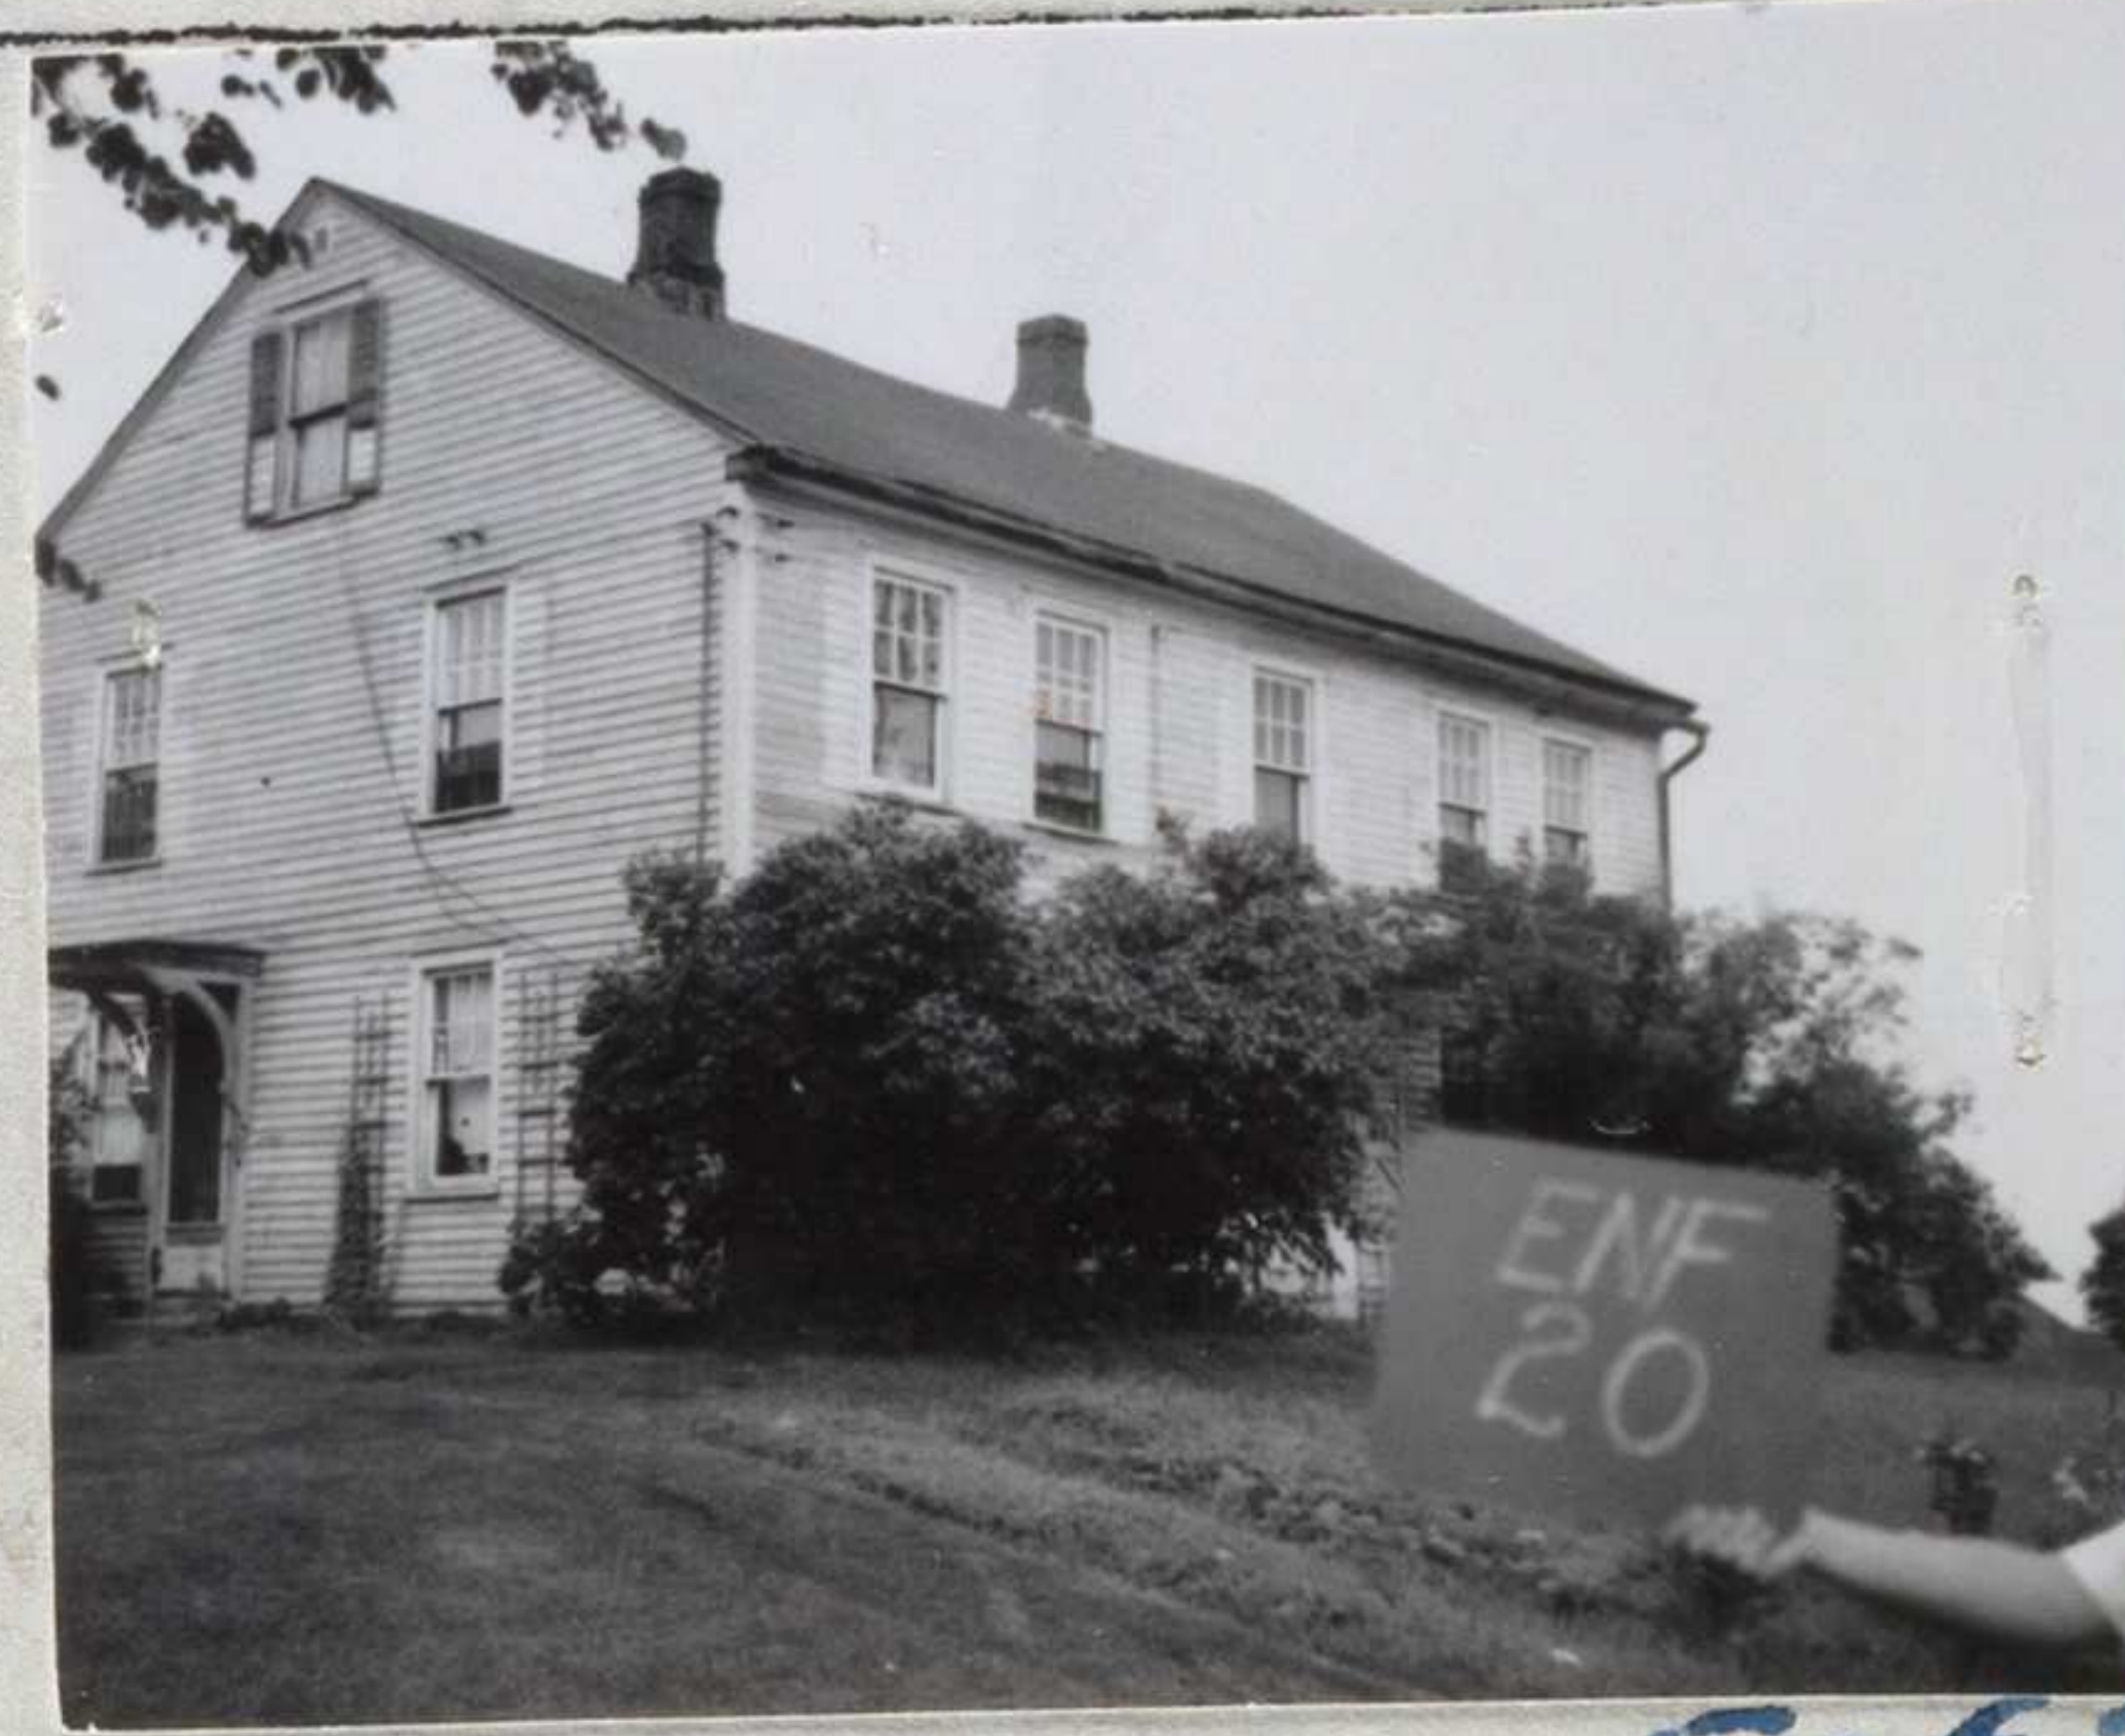
7. PHOTOGRAPH *Enf 20*

This house is unfortunately in quite poor condition. Architectural integrity has been no consideration in its transformation from its original form. The foundation ~~is~~ is of cut brownstone. The house's ~~is~~ facade is in five bays. The roof has a medium pitch. The central chimney and windows are replacements. The door, however, is the original simply pilastered form. Since writing the paragraph we discovered that this house was the first printing location in Enfield

5. PHYSICAL CONDITION OF STRUCTURE Endangered? Interior *poor* Exterior *poor*
